## Case 418 : Narrative

Case Vehicle (A): 2000 Ford	Vehicle (B): 1993 Volvo
Type: Contour SE, 4-door sedan	Type: 850 GLT, 4-door sedan
Driver: 29-year-old male	Driver: 16-year-old male
CDC: 12-FDEW-1	CDC: 99-0000-0

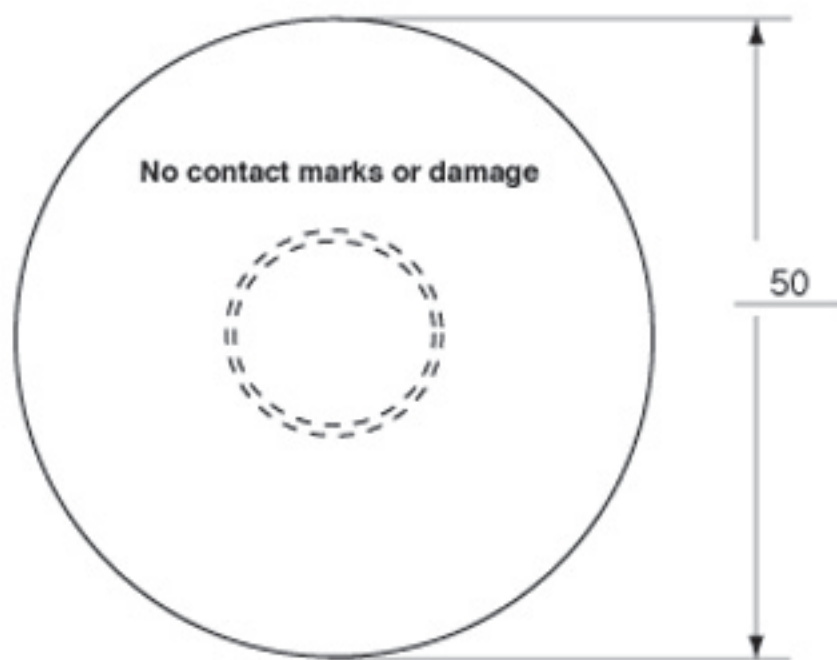
Driver Airbag

Vents: ☒ Y ☐ N

if yes, how many: 2

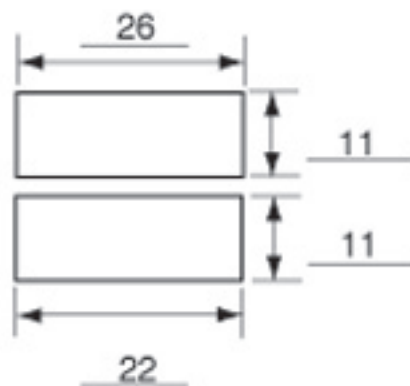
Driver Airbag Doors

H-Pattern

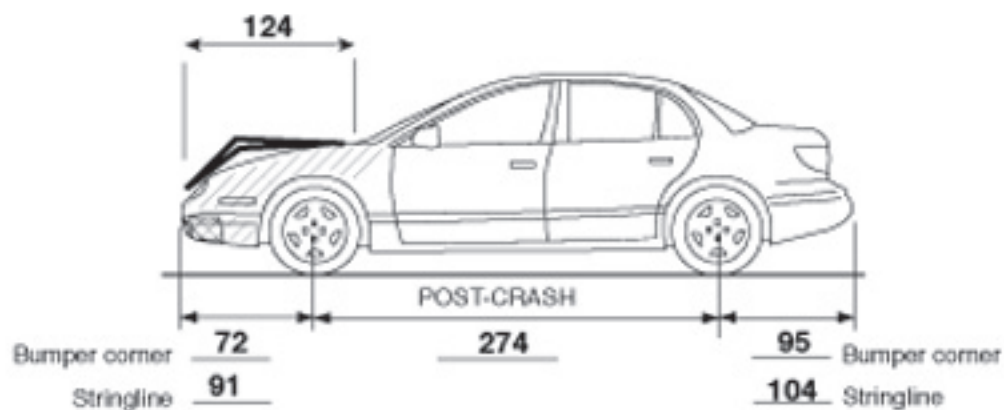
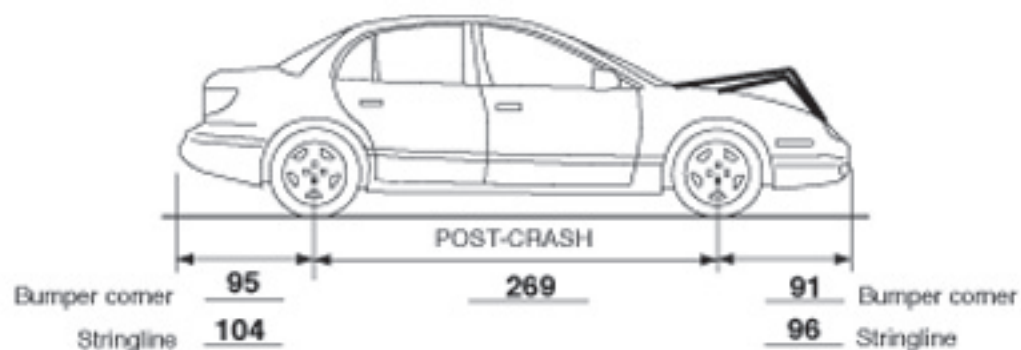
5 cm  
Max crush

133 cm  
Direct damage  
length

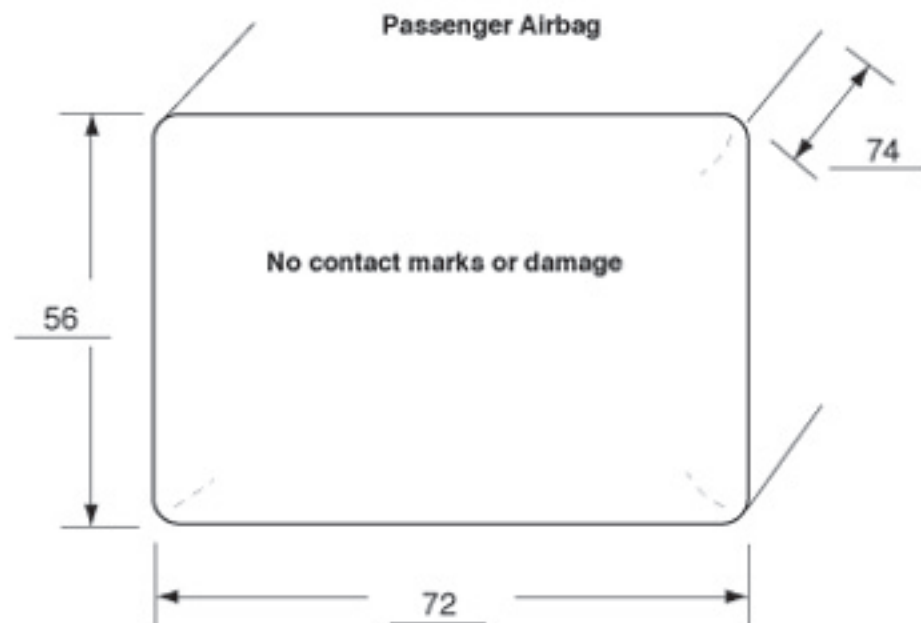
Vents: ☒ Y N  
 if yes, how many: 1  
 vent @ 10 o'clock

Tethers: ☒ Y N  
 if yes, how many: 2
